Prepared For: Daniel Fu and Lyn Jing

Property Address: 13792 Pierce Rd
Saratoga, CA 95070

Inspector: Dan McPhee
Company: Dan McPhee
dba WIN Home Inspection San Mateo
(650) 375-0400
dmcphree@wini.com

Extended Home Inspection

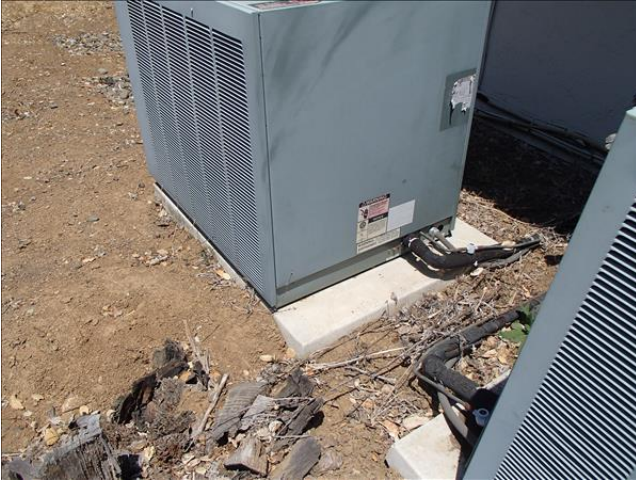
Figure 1

The condensers for the AC system were not properly secured to the ground. Consult an HVAC professional.

Air Conditioning

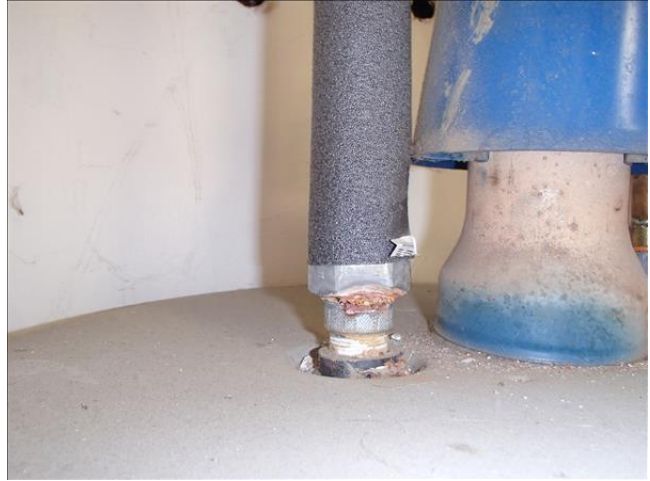
Figure 2

There is visible encrustations along the water connection at the top of the water heater. Consult a plumber for repair.

Water Heater
Evidence of Encrustation
Yes

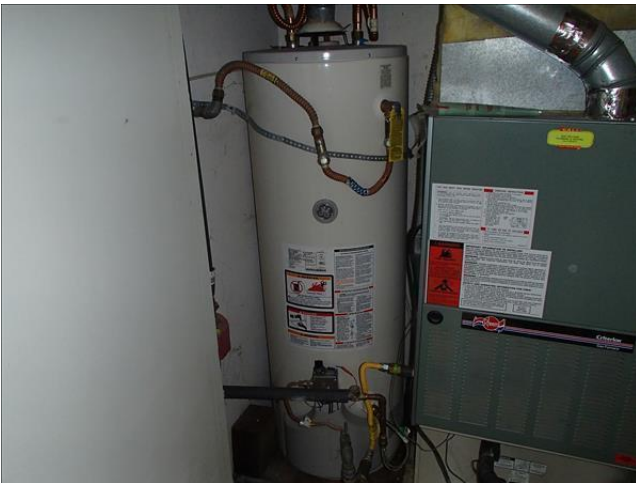
Figure 3

Safety Upgrade: As of 1/1/1996, all residential water heaters, new or replacement, must be strapped or braced. Both water heaters do not appear to meet the state standards for strapping and/or bracing requirements for earthquake safety. These standards may or may not be different than local codes. We suggest the strapping meet local and/or the state standards. If unsure of local requirements, we recommend you contact your local building

department for consultation. State approved seismic strapping kits are available at most hardware and home repair stores.

Water Heater
Safety Tie Down(s)
Attention

Safety Upgrade: As of 1/1/1996, all residential water heaters, new or replacement, must be strapped or braced. Both water heaters do not appear to meet the state standards for strapping and/or bracing requirements for earthquake safety. These standards may or may not be different than local codes. We suggest the strapping meet local and/or the state standards. If unsure of local requirements, we recommend you contact your local building department for consultation. State approved seismic strapping kits are available at most hardware and home repair stores.

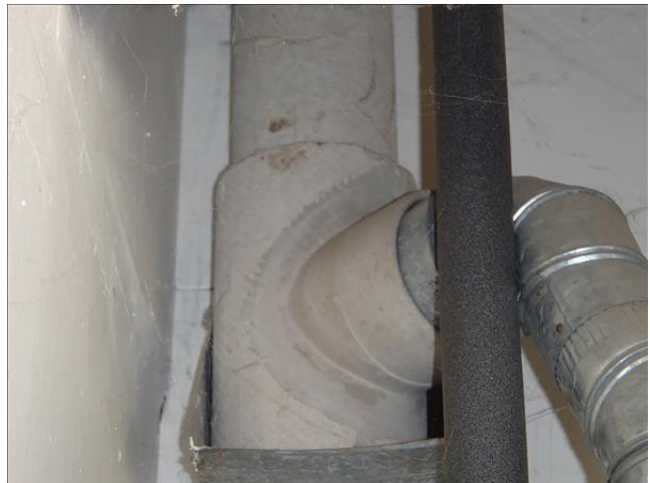
Figure 4

The inspector noted that the flue for the water heater in the garage appeared to be transite. We recommend replacing the transite flue with a metal flue.

Water Heater
Installation
Maintenance - Flue

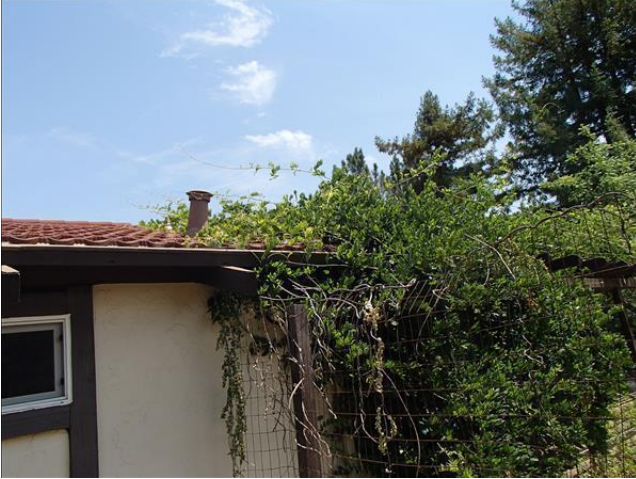
Figure 5

There is vegetation growing up against the exterior surface material. All vegetation should be trimmed at least 6-12 inches away from the structure to eliminate a common avenue for pest infestation and damage to the exterior structure material.

Structure Perimeter Exterior
Vegetation Clear from Structure
No

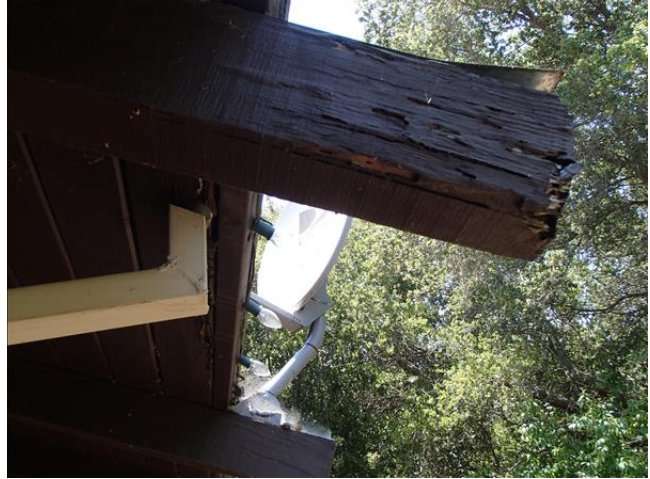
Figure 6

Wood deterioration was observed at the areas of the trim, eaves and fascia. Consult the most current pest report for recommended repair.

Exterior Structure
Fascia Boards / Trim
Maintenance

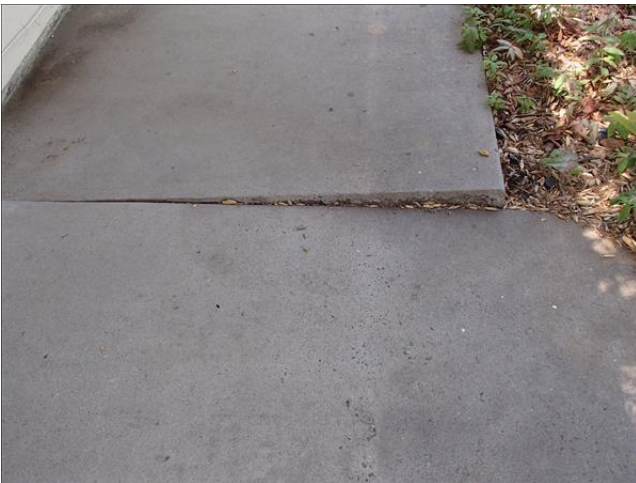
Figure 7

We observed uneven concrete around the perimeter of the structure. Consideration should be given for patching these areas to prevent tripping.

Patios/Decking/Porches
Concrete Slab
Attention

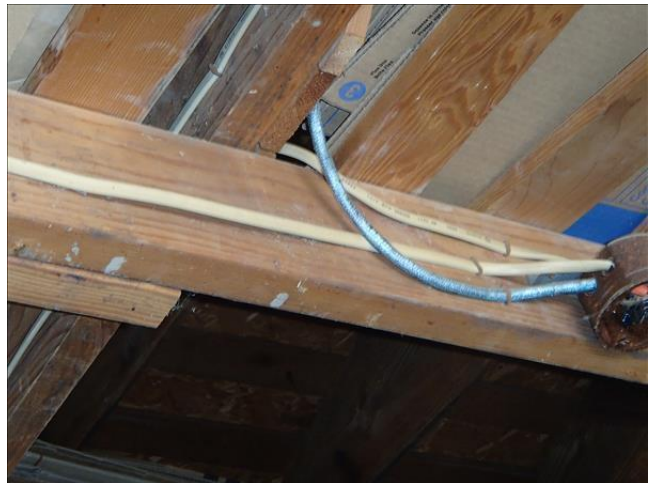
Figure 8

The inspector noted miscellaneous electrical issues that are in need of repair by a qualified electrical expert for safety considerations:

1. COVER PLATES - Cover plate(s) in the garage were missing and should be replaced for safety reasons.
2. EXPOSED ROMEX - Exposed romex in the garage should be in a metal conduit to provide proper protection to the wiring system.

Electrical Service
Plugs, Switches, Junction Boxes, Lighting
Maintenance

- 1. COVER PLATES - Cover plate(s) in the garage were missing and should be replaced for safety reasons.*
- 2. EXPO ROMEX - Exposed romex in the garage should be in a metal conduit to provide proper protection to the wiring system.*
